## POWER CABLE DEFECTS AND THEIR INFLUENCE ON ELECTRIC FIELD DISTRIBUTION IN POLYETHYLENE INSULATION

**Kucheriava I.M.**

*The paper studies the cable degradation mechanisms and electric field distributions in the polyethylene insulation of power cables with typical defects at macroscopic level including crack and numerous air bubbles in the insulation, protrusion of inner semiconducting layer, its air gapping with cable insulation and interruption along the cable conductor, holes in outer semiconducting layer, its delamination from copper shield as well as small air hole in the shield owing to corrosion. The three-dimensional computer modeling and analysis of electric field distributions are carried out in the chosen region of the cable containing the defects. The patterns of the distributions and local field enhancement in the vicinity of the defects are shown. The effect of defects on electric field in the polyethylene cable insulation is revealed.*

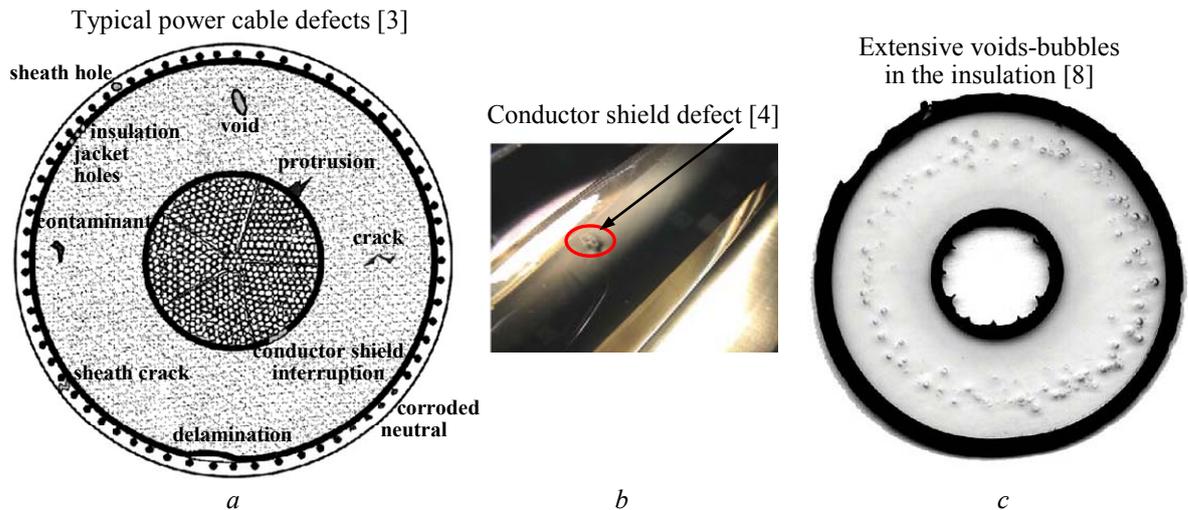
**Fig. 1**

Starting from the center, XLPE insulated cable consists of current carrying conductor, conductor shield (or inner semiconducting layer), polyethylene insulation, insulation shield (outer semiconducting layer), metallic (copper) shield and non-metallic jacket (fig. 1, a).

The conductor is the most necessary element of cable. It carries the electrical current and has two designs for high-voltage cables, namely round stranded or segmental Milliken stranded conductor as in fig. 1, a.

The insulation of power cables needs separate attention. According to fig. 1, the polyethylene insulation includes both volume defects (such as conducting and non-conducting impurities, air voids and cracks) and surface defects owing to the roughness and imperfections of adjacent semiconducting layers. The voids, contaminants in the insulation, its gapping with the layers and other design and manufacturing defects result in the stress and electric field concentrations within the cable. For example, the micro-sized inclusions and water-filled voids cause field enhancement, initiation of water tree growth, resulting in accelerated insulation aging and premature failure of the cable [2]. The defects are the initiation sites for water treeing because of increased local electric field. Water trees occur in the presence of water in the insulation and are accompanied with partial discharges which can deteriorate the insulation and accelerate its failure. The discharges are

The power cables age as time progresses. They age, deteriorate and fail depending on many factors such as electrical, thermal, environmental, mechanical factors, factor of time, imperfect XLPE insulation [3]. The typical power cable defects are shown schematically in fig. 1, *a*. It is important that the defects can grow with time.

*The purpose of the present work* is to study electric field distribution in the insulation system of XLPE insulated power cable with typical macroscopic defects namely cracks and extensive voids-bubbles (fig. 1, *c*) in the insulation, interruption of inner semiconducting layer along the cable conductor, protrusion of the layer into the insulation (in accordance with fig. 1, *a, b*), air gap between the layer and the cable insulation, delamination of outer semiconducting layer from metallic shield, holes in the layer and small air hole in the copper shield because of its corrosion. The single conductor XLPE insulated 110 kV power cable is

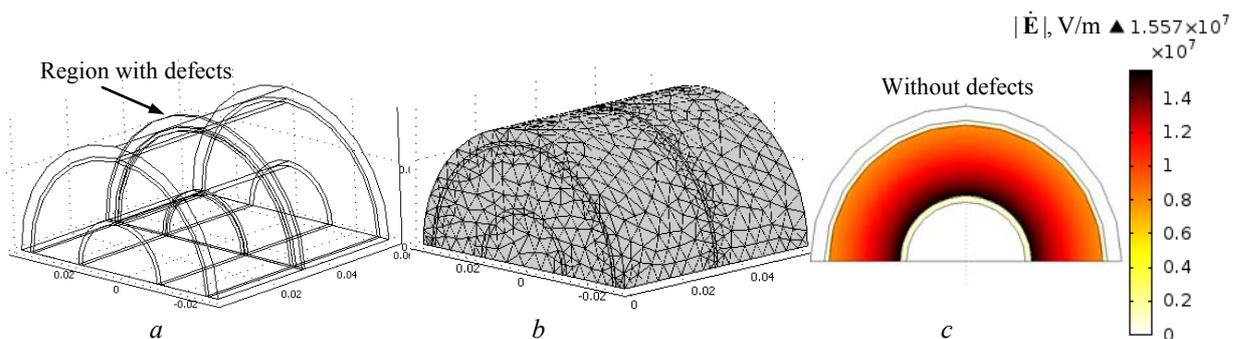
Fig. 2

**Model for computations.** The model is presented in three-dimensional Cartesian coordinate system. The computational region of electric problem includes polyethylene insulation, semiconducting layers and copper shield in the half part of the cable (fig. 2, a). The conductor and jacket of the cable are left out of account.

The computational region contains the half part of the cable with defects (fig. 2, a). Taking into account the cable symmetry and preset boundary conditions, it means that the same defects exist in the other symmetric part of the cable. This may be assumed because the increased electric field takes place only in the local zones near the defects.

The finite element mesh is generated as shown in fig. 2, b. The mesh resolution is increased at the location of the defects, especially at their sharp tips and at the interfaces with cable elements.

The computed electric field distribution in the insulation without defects as well as the color legend with electric intensity values is presented in fig. 2, c for subsequent comparison with different types of defects (figs. 3–5). Note that the field distribution in the insulation without any defects can be calculated not only numerically but also analytically using formula from [11].

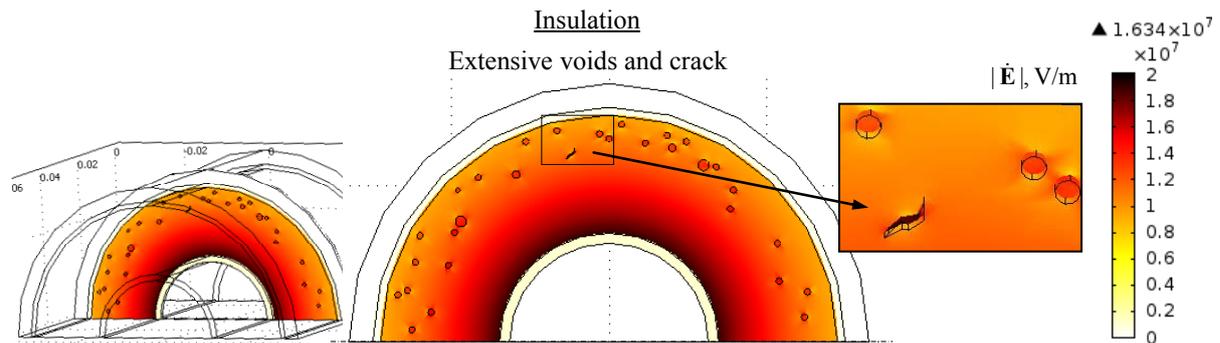
Fig. 3 gives the pattern of electric field in the polyethylene cable insulation containing extensive voids-bubbles and crack in compliance with fig. 1, *a, c*. As seen, the electric intensity increases at the sites of the defects and the interaction of neighboring voids is taken place (fig. 3 at the right). In the case under consideration, the voids are in the part of the insulation where leaving out of account the defects, the electric field is equal to  $|\dot{\mathbf{E}}| = 8-9$  kV/mm according to fig. 2, *c*. Then the degree of field inhomogeneity for the insulation with voids-bubbles and crack near the outer semiconducting layer (fig. 3) is evaluated by

As shown by computer modeling, the weak areas in the polyethylene insulation with high electric intensity are formed due to cracks and macroscopic voids-bubbles in the insulation (fig. 3), air gapping, interruption of inner semiconducting layer along the cable conductor and sharp protrusions of the layer into the insulation (fig. 4). These defects are able to interact with each other (fig. 3 at the right), tend to reduce the dielectric strength of the insulating material and lead to its degradation.

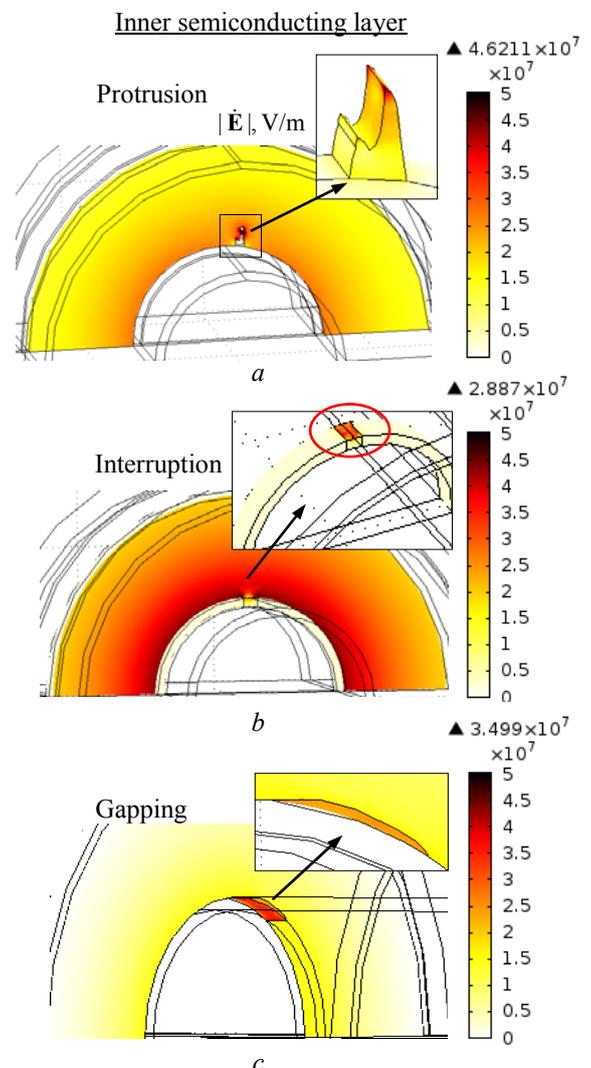
Fig. 4

The protrusion of the inner semiconducting layer into the insulation (fig. 4, *a*), interruption of the layer (fig. 4, *b*) and its air gapping (fig. 4, *c*) are dangerous in the context of increased electric intensity (as compared to fig. 2, *c*). As shown, such defects contribute to the reduction of dielectric strength of the insulating material. The peak value of electric field takes place at the sharp tip of the protrusion (fig. 4, *a*). This is a weak area of the insulation close by the cable conductor.

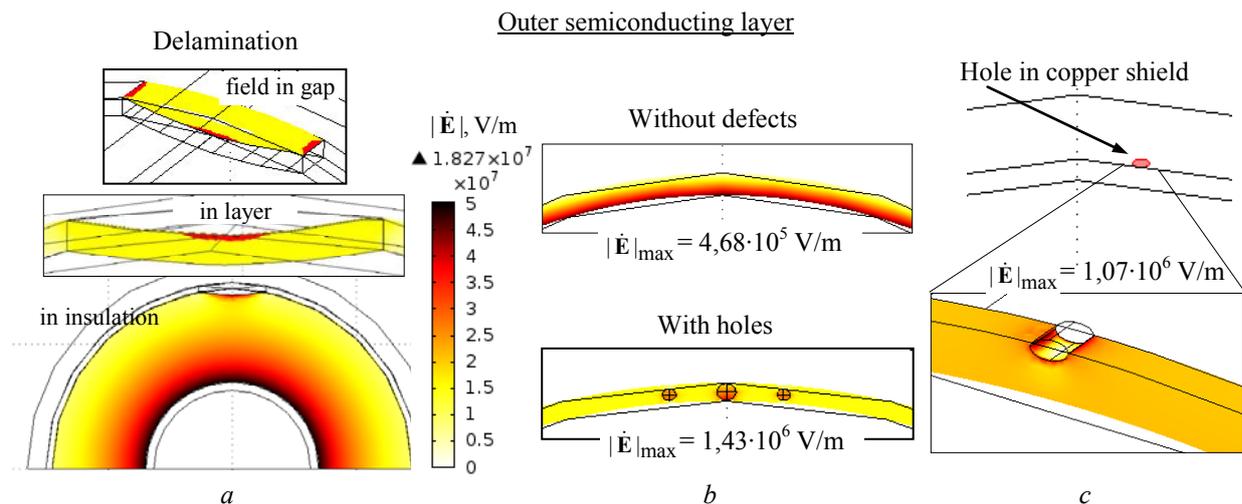
Fig. 5

The delamination of outer semiconducting layer causes the increase of electric intensity both at the interface with the insulation and within the layer (fig. 5, *a*). The field is maximum at the sites of the layer separation as shown at the top of fig. 5, *a*.

The electric field distributions in the outer semiconducting layer without any defects, with several holes and with small air hole at the interface with copper shield owing to its corrosion are illustrated in fig. 5, *b* and *c*. In the last case the field is shown only in the semiconducting layer excluding the air gap appearing in the layer. As revealed by modeling, the defects have no direct influence on electric field in the insulation but taking into account the time factor and possible generation of electrical discharges, the defects under study can cause erosion of the semiconducting layer and subsequently the cable insulation.

The delamination of outer semiconducting layer from the cable copper shield gives rise to electric field enhancement around the layer separation and at the contact of the delaminated layer with the insulation (fig. 5, a). The holes inside the semiconducting layer and air gap in the cable shield owing to its corrosion during the cable operation modify the electric field configuration in the layer and have no direct influence on the field distribution in the insulation. Nevertheless, in the course of long time they may affect on the field in the cable insulation.
